Ultrasonographic Evaluation of Flexor Pollicis Longus Tendon and Volar Locking Plate of Distal Radius Fracture

Masatoshi Takahara, MD, PhD, Chieko Hirano, Masahiro Maruyama, and Tadanobu Nemoto
Center for Hand, Elbow, and Sports Medicine, Izumi Orthopaedic Hospital, Sendai, Japan

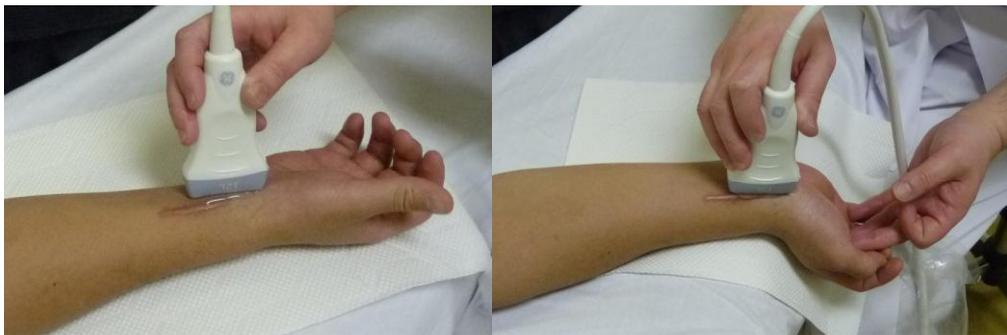
Fig 1. ultrasonography of FPL tendon

Methods: The subjects were 28 wrists of 27 patients who underwent the removal of the volar locking plate. Before the plate removal, radiography and ultrasonography were performed to assess the relation between the FPL tendon and the volar locking plate (Fig 1, 2). Intraoperatively, we evaluated the risk of tendon rupture as follows: the risk was low if there was an intact muscle belly or dense fibrous scar between the FPL tendon and the volar locking plate, and high if there was only a thin see-through membrane or less (Fig 3). Comparison was made between preoperative and intraoperative findings.

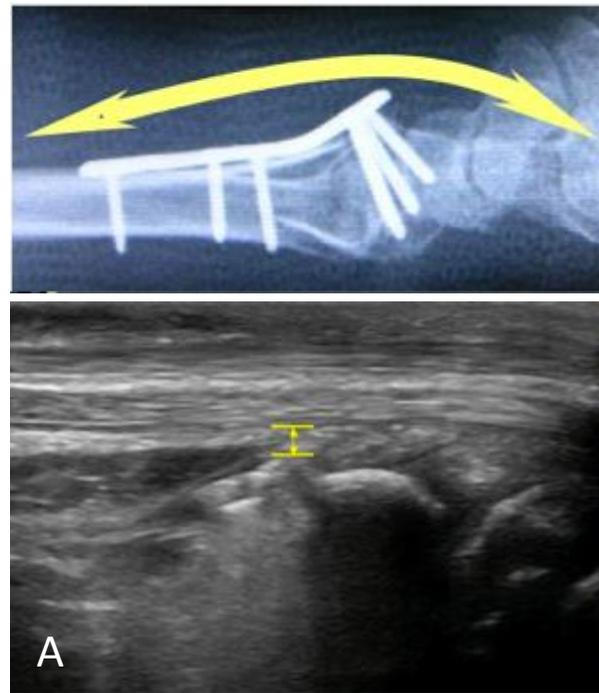
Fig 2. ultrasonographs of FPL tendon. FPL tendon was compressed (B)

Result: The risk of FPL tendon rupture was strongly related to the distance between the FPL tendon and the volar locking plate in ultrasonography. The sensitivity to detect the high risk of FPL tendon rupture by ultrasonography was 95% and the specificity was 89% if the distance between the FPL tendon and the plate was less than 0.7 mm (Table 1), and 100% and 44% respectively if the distance was less than 0.9 mm. FPL tendon compression was seen in eleven cases (39.9%), which suggested the high risk of tendon rupture.

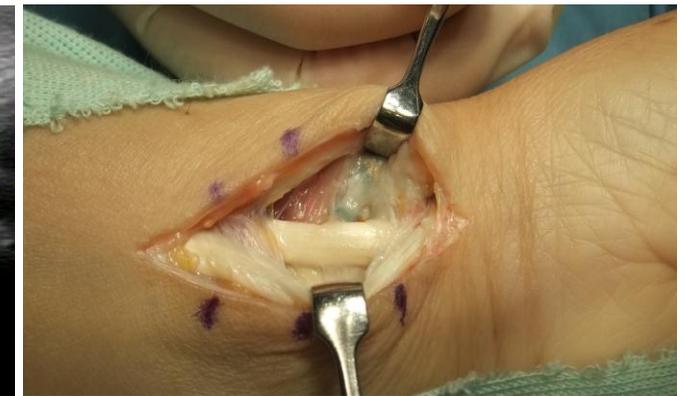
Fig 3. high risk case
